Article No.:	4010 0270

Description:	Alteration of HP 336 to full capacity	
Date / Page:	12th September 2007 / 1 of 1

## Alteration of HP 336 to full ink capacity

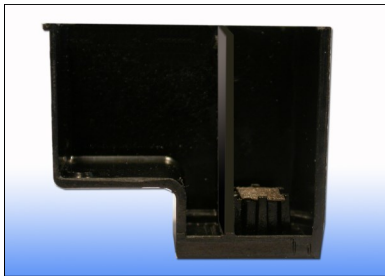
1a) Cross-section of HP 336 with separating wall.

The ink cartridge HP 336 has a separating wall within the ink chamber (see Fig. 1a). After removing this separating wall by either cutting or breaking them out the full cartridge capacity can be utilised (see Fig. 1b). The ink supply of the HP 336 to the preceding nozzle chamber (filter area) is lower than for example with the HP 338 ink cartridge. This difference in height is bridged by a custom formed sponge (see Fig. 1c). Using this sponge the chamber will be completely filled. Samples are available on request.

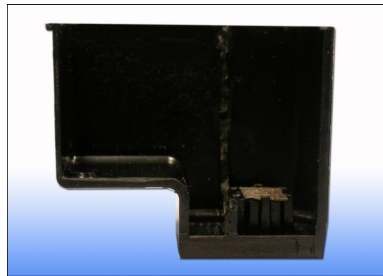
1b) Cross-section of cartridge after separating wall has been removed.

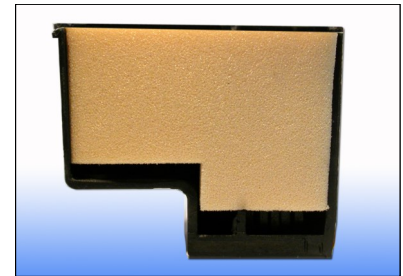
1c) Cross-section with inserted sponge.
